TECHNICAL REPORT REMR-CO-3

CASE HISTORIES OF CORPS BREAKWATER  
AND JETTY STRUCTURES

Report 6

NORTH PACIFIC DIVISION

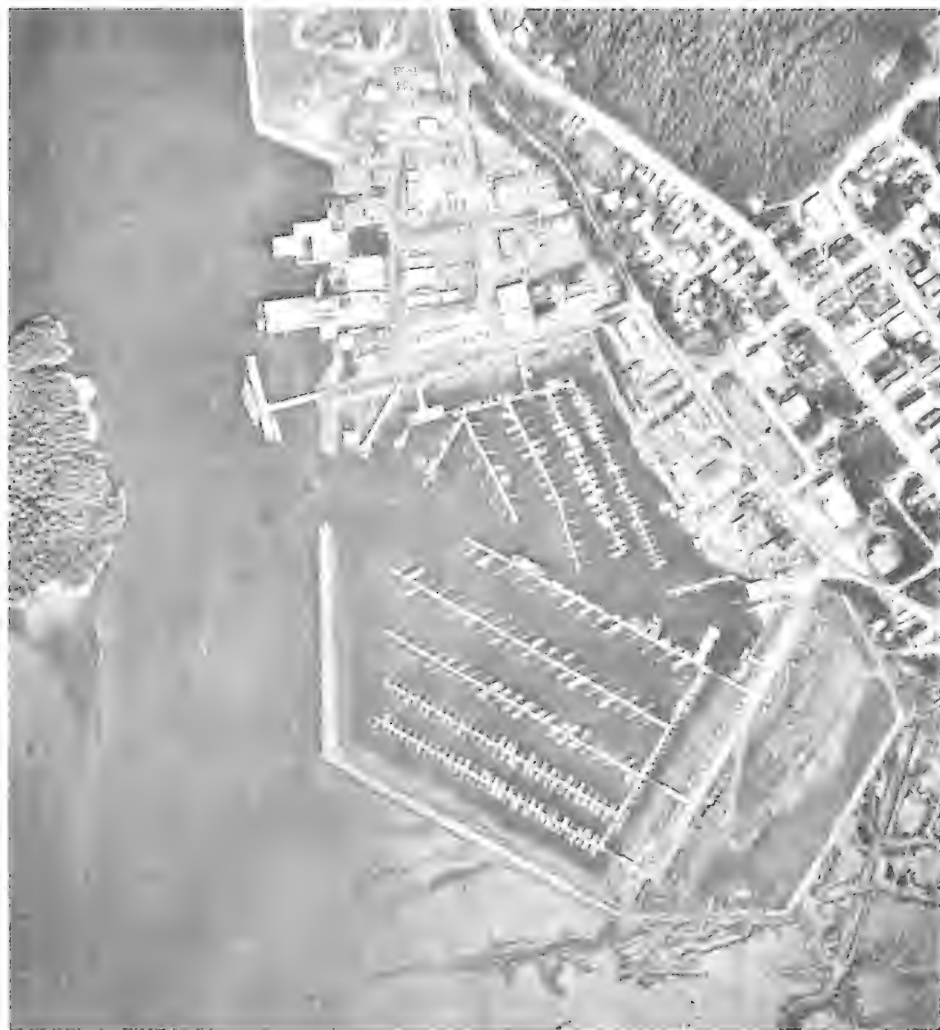
Figure 6. Aerial photograph of Cordova Harbor, Alaska, 1984

1985	The harbor is illustrated in Figure 5, and an aerial photograph of the harbor is presented in Figure 6. The breakwaters appear in good condition at this time.

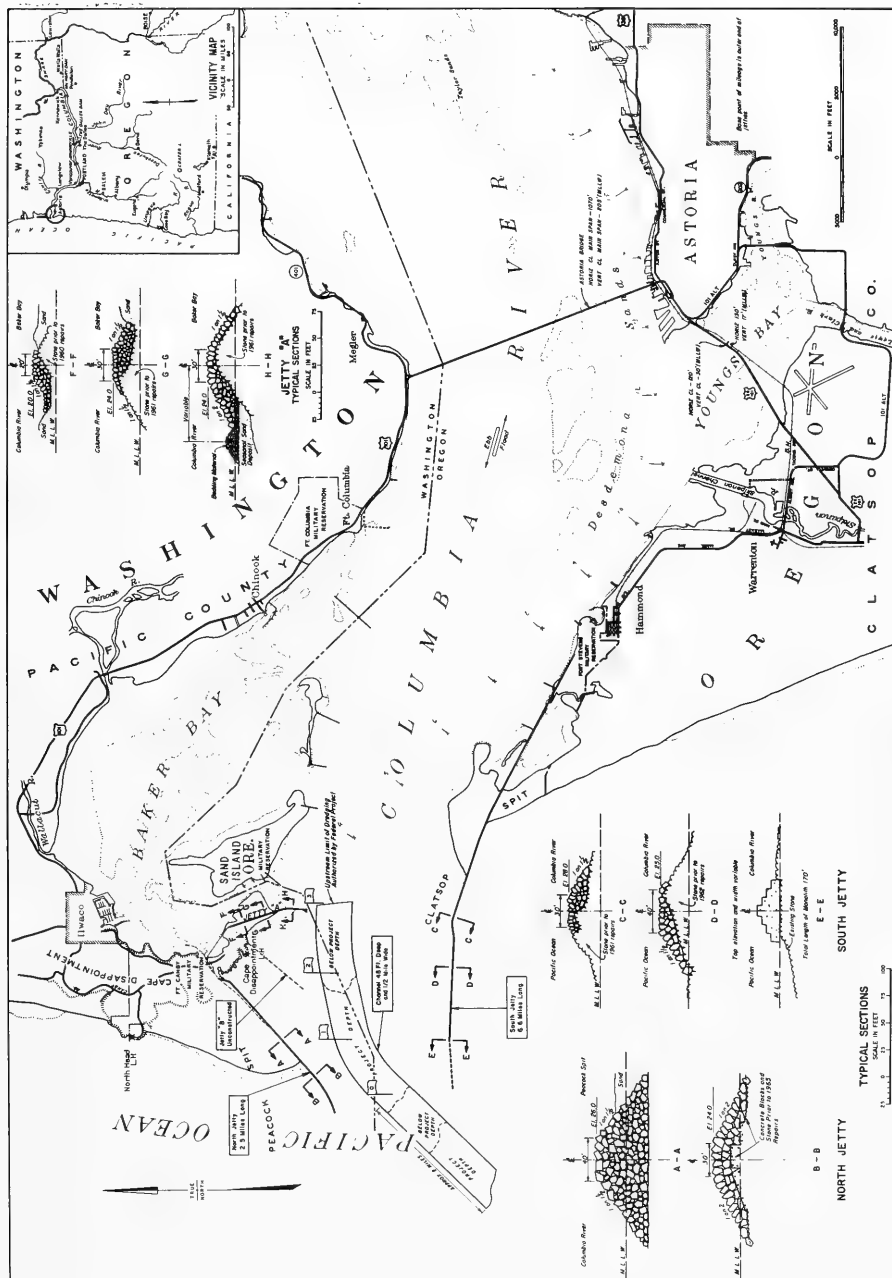
Figure 53. Site layout of Columbia River at Mouth, Oregon and Washington (revised 1979)

1964- 1965	The south jetty was repaired from "knuckle" to sta 158+00 with 308,101 tons of stone.
1965	The north jetty was rehabilitated with 136,935 tons of stone.
1982	The south jetty was repaired from sta 38+00 to sta 158+00 by filling of cavities in the structure.
1985	The harbor and cross sections of the jetties are illustrated in Figure 53. The north jetty and training jetty "A" have scour problems at the heads. The south jetty is in need of repair.

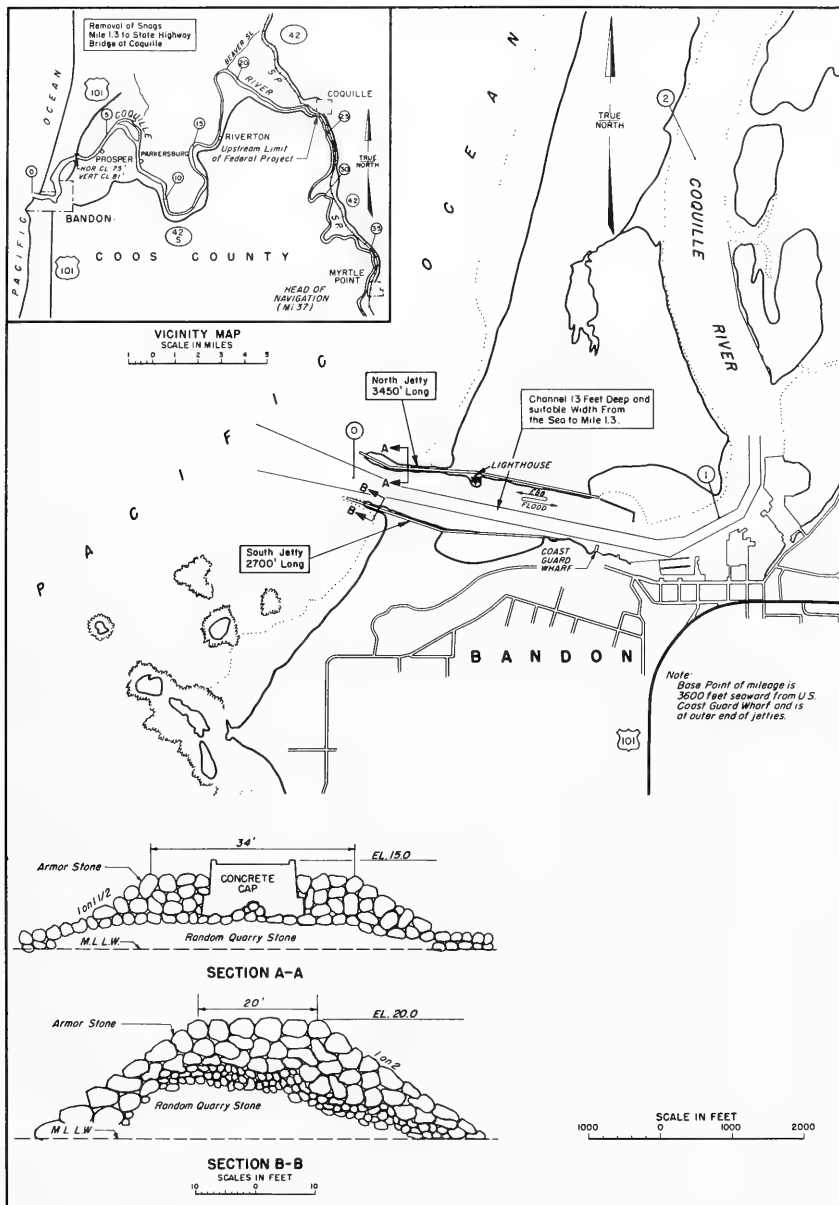
Figure 55. Site layout of Coquille River, Oregon (revised 1981)

1956	The north jetty was repaired, including placing concrete under the jetty cap in voids caused by erosion of the cap foundation stones and placing jetty stone along the north and south sides of the jetty cap. Stones were 50 percent class "A", weighing at least 4 tons and averaging 6 tons, and 50 percent class "B", weighing at least 1 ton and averaging 2 tons.
1982	The small-boat basin was constructed at Bandon, Oregon, including construction of a rubble-mound breakwater about 350 ft long with a crest elevation of +14 ft mllw and a crest width of 6 ft.
1985	The harbor and cross sections of the jetties are illustrated in Figure 55. The head of the north jetty is in need of repair, but it is still functional. The south jetty is in good condition.

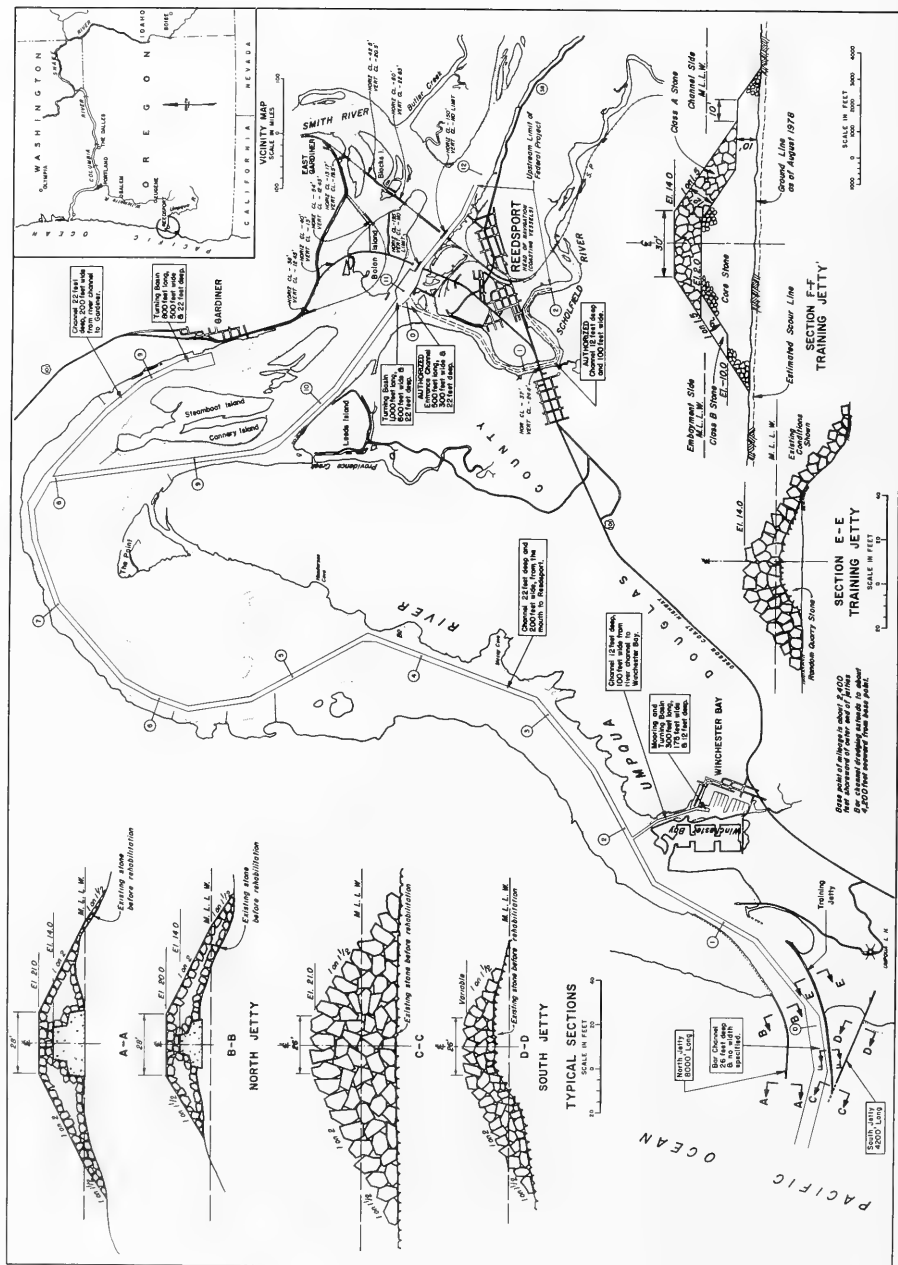
Figure 64. Site layout at Umpqua River, Oregon (revised 1981)

1985	The harbor and cross sections of the jetties are illustrated in Figure 64. The jetties appear in good condition at this time.
